Mynydd Maen Action Group

Report on RPS Document “Cil Lolydd Solar Farm Phase 1 Peat Probing”

(RPS document dated 13th March 2025)

Prepared by CDH 10/04/2025

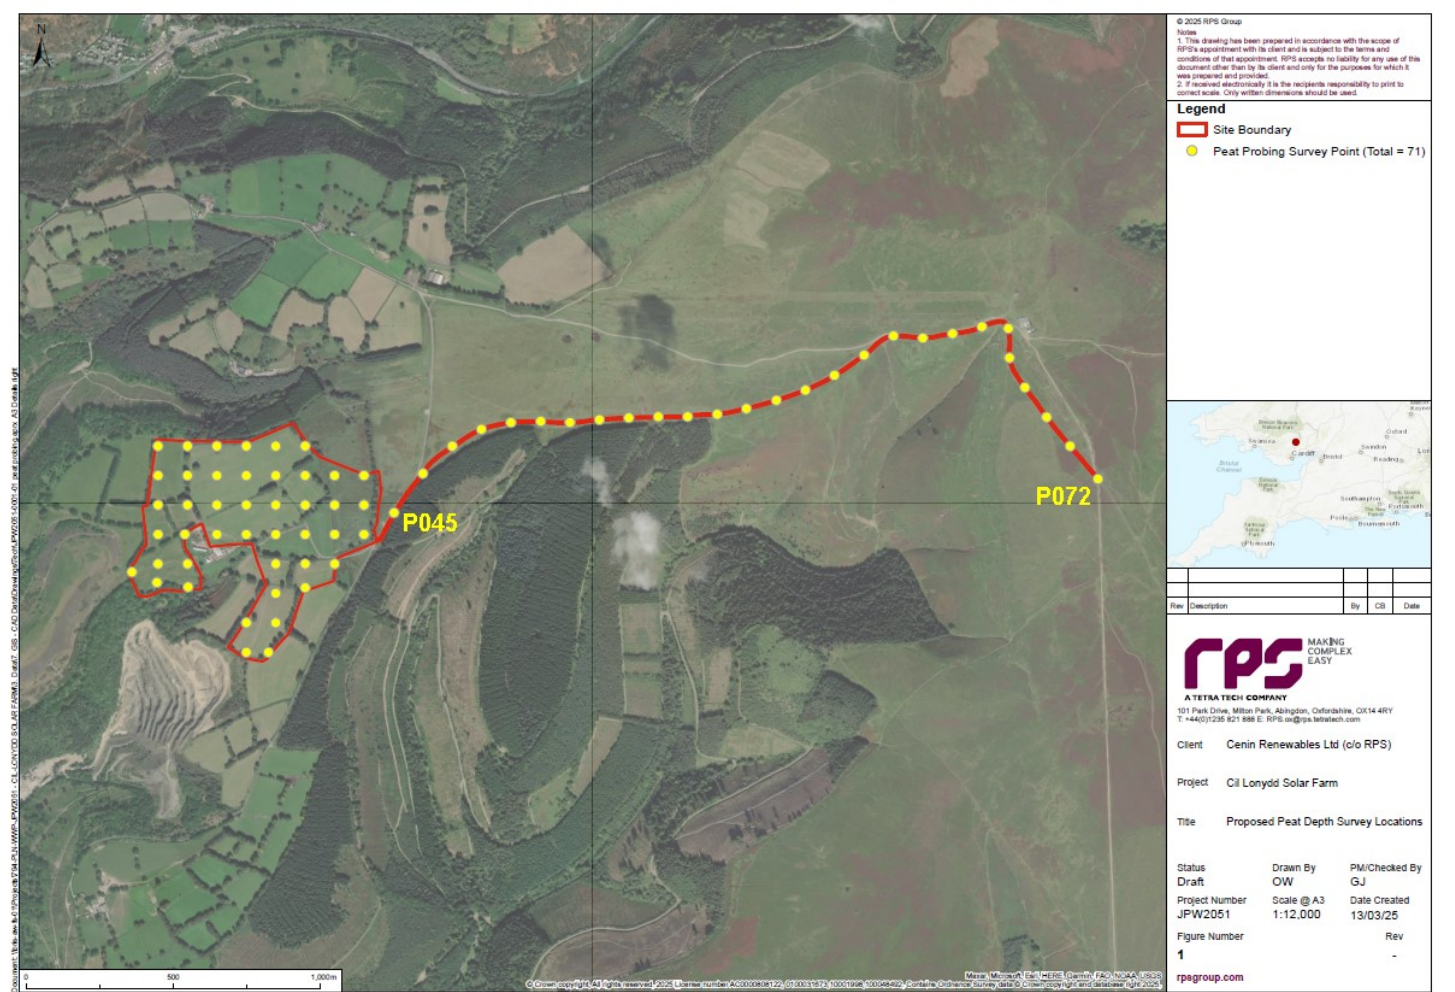
Below is Figure 1, from the RPS probing report, to which we have added the position numbers (P045-P072) of the coordinates that we were interested in, that is, those on the common. Point 066 appears to be missing from RPS' peat report.

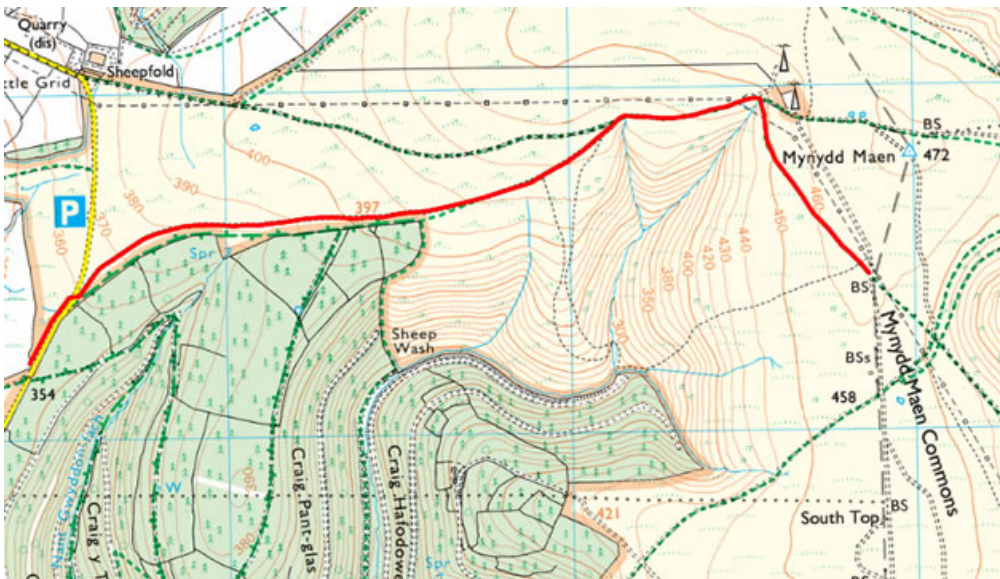
Our belief is that the person planning this cable run did not survey the site, they just traced the obvious green line on the OS map, as we have done on the left.

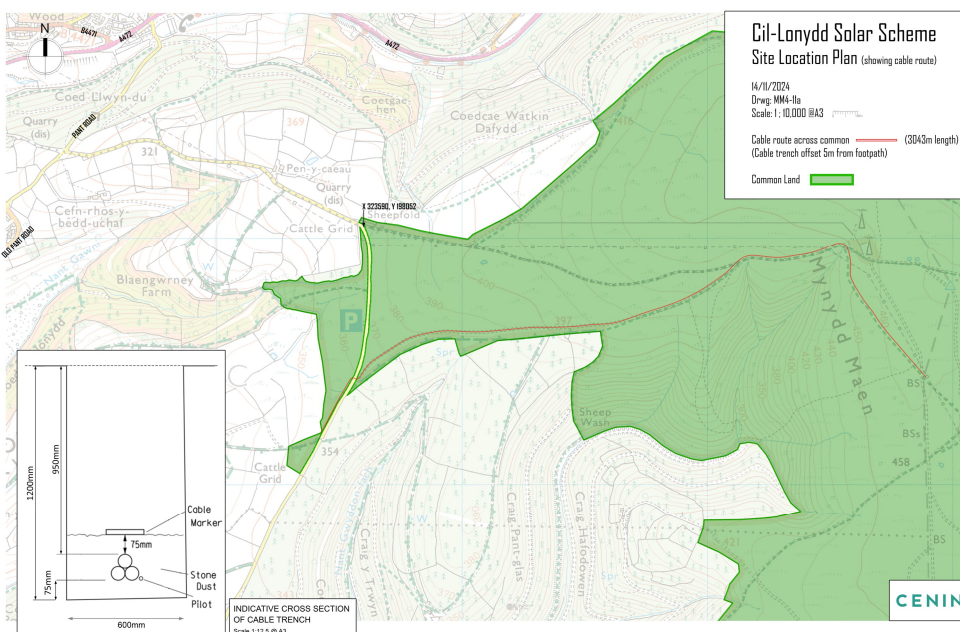
This is exactly how it ended up! If the applicant had actually visited site they would have realised that, after the gas station, they were following a non existent path.

Furthermore, the cable route extends well beyond the RES substation, when examined on the ground.

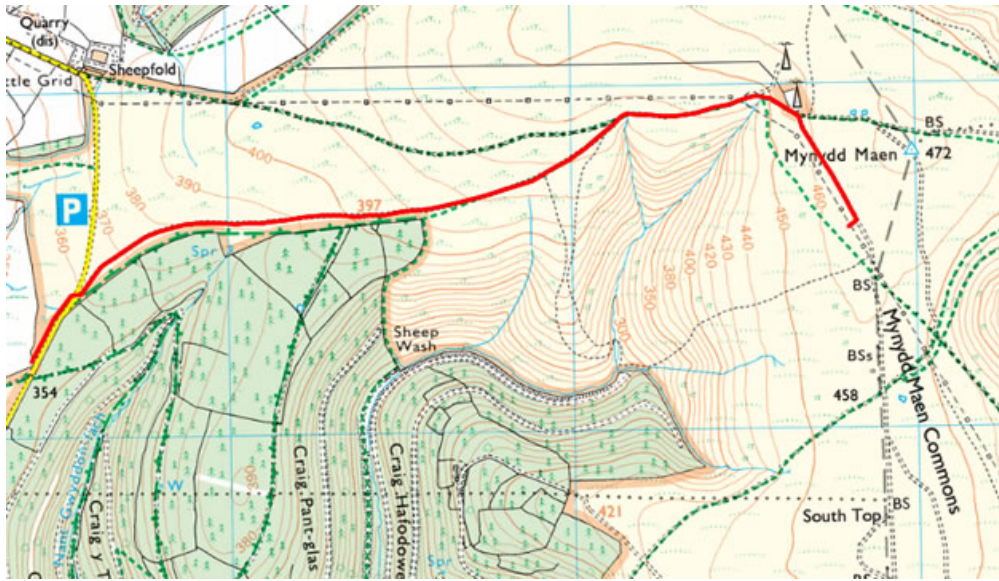
An in-person site visit would have resulted in a far more practicable cable route such as we suggest below. This route follows the gravel track south from the gas station and the mast.

We suspect this last section must be the route that the peat surveyor followed, seemingly without the benefit of any GPS location.

In our view, a far less damaging cable route could have been planned by actually surveying the proposed route and choosing to design the cable trench to follow the existing tracks and ruts, generally avoiding peat, and actually following the gravel roads where they exist.

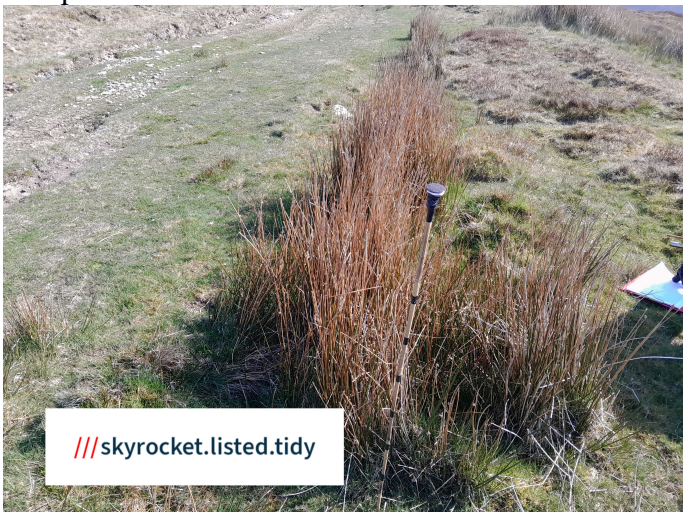
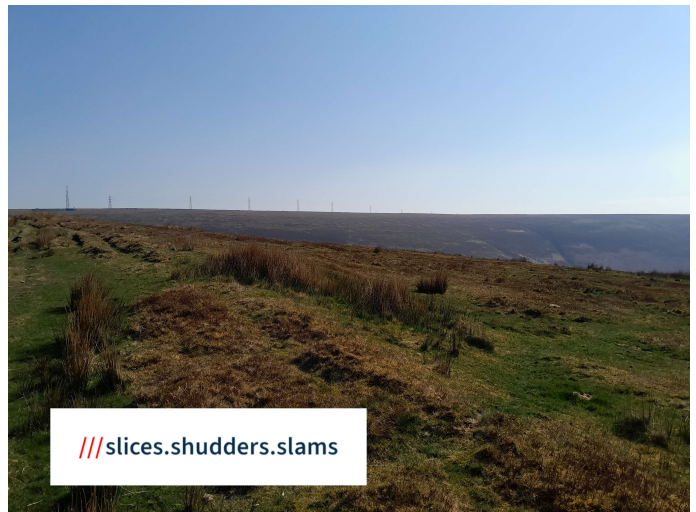
Our pictures at P057

P057	3	0.00	Granular	<Null>	not recorded		see photos, not on track
P058	2	0.00	Granular	<Null>	200	peat	Wimberry bushes
P059	2	0.00	Granular	<Null>	200	peat	Wimberry bushes
P060	2	0.00	Granular	<Null>	150	peat	Still not on actual track
P061		0.00	Granular	Compressed track	0		alongside wide rutted tracks
P062	2	0.00	Granular	<Null>	150	earth no peat	alongside track
P063		0.00	<Null>	Gravel track	0		Gravel Track
P064		0.00	Granular	Gravel track	0		1m from edge of gravel track
P065		0.00	<Null>	Gravel track	100	peat	8m from gravel track
P067	4	0.00	<Null>	Gravel track	200-300	soil	NOTE there is no P066!
P068	4	0.00	<Null>	Gravel track	200	peat	rushes
P069	4	0.00	<Null>	Gravel track	150-200	peat	Path through rushes
P070	4	0.00	<Null>	Gravel track	150-200	peat	lots of rushes, winberries
P071	4	0.00	<Null>	Gravel Track	400	peat	In proposed grid conection compound
P072		0.00	<Null>	Gravel track	0	stone track	on gravel road junction well past grid connection

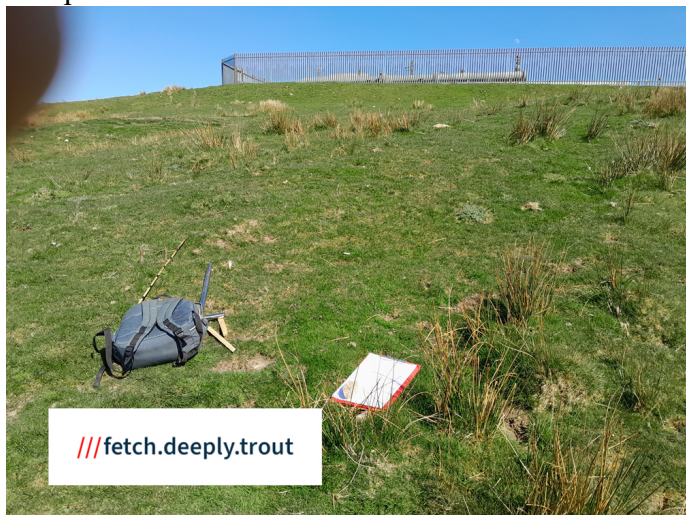
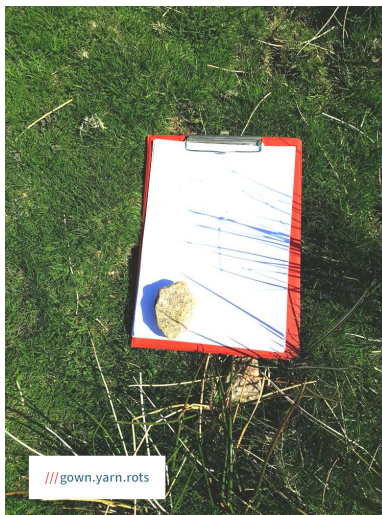
Our pictures at P067

Furthermore from P067 to P072 it appears that they followed the obvious route, along the gravel road, rather than the route that is set out by the given coordinates and as indicated by their map (Figure 1 above). The route indicated on the map and by the coordinates follows a PRoW marked in the OS map which is neither used nor visible on the ground.

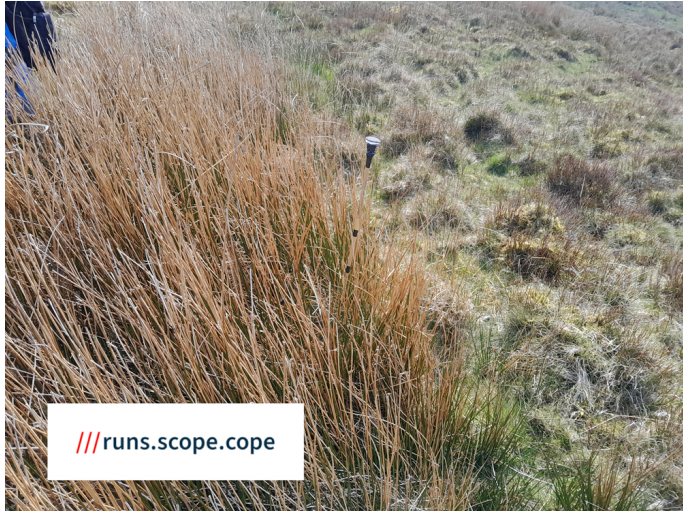
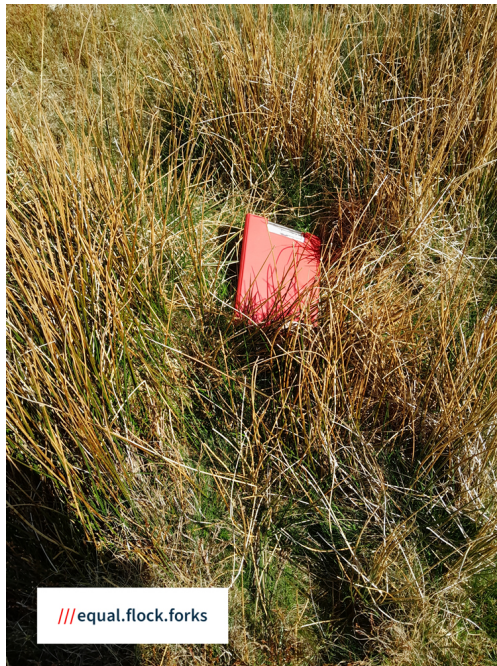
RPS report show no pictures from P068 to P071 but RPS say there is no peat and gravel track at these positions.
