Mynydd Maen Action Group

Report on RPS Document “Cil Lolydd Solar Farm Phase 1 Peat Probing”

(RPS document dated 13th March 2025)

Prepared by CDH 10/04/2025

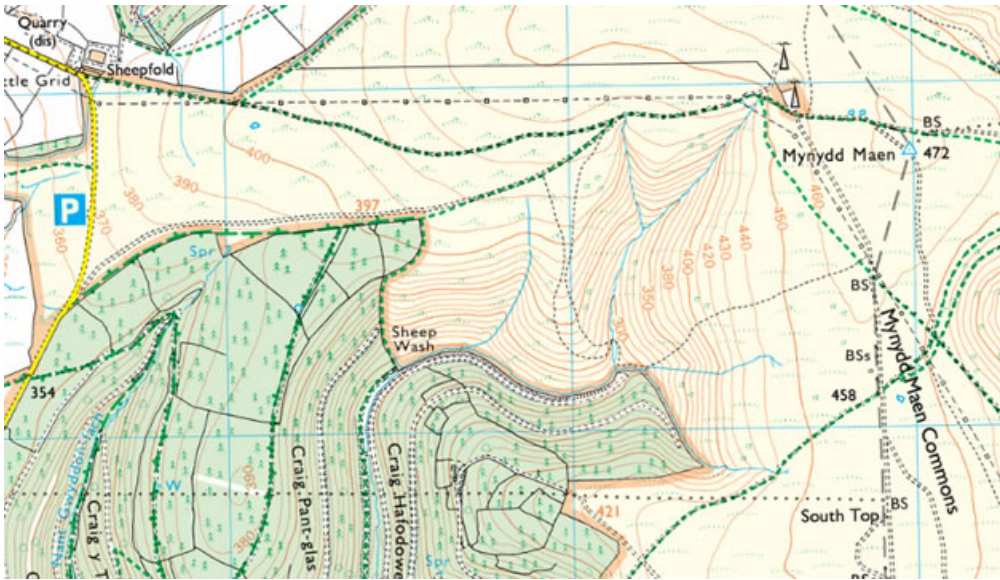
OS Map

Furthermore from P067 to P072 it appears that they followed the obvious route, along the gravel road, rather than the route that is set out by the given coordinates and as indicated by their map (Figure 1 above). The route indicated on the map and by the coordinates follows a PRoW marked in the OS map which is neither used nor visible on the ground.

On this map the PROWs, in green, which sometimes follow the tracks, are more prominent than the tracks without the green dashed footpath lines.
